## IMPORTANT NOTICE AS-09 SWATCH BATCHES

09 January 2009

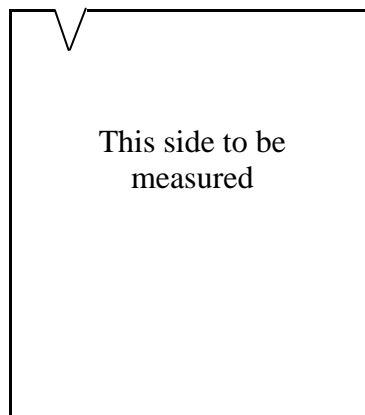
Subsequent investigations have revealed that there was in fact no particular issue with the initial reflectance readings for this batch. The error in measurement occurred because the test laboratory had been reading the wrong side of the swatch in some cases. Until recently most swatch orders included ink markings on the swatch by which the user could identify the correct side for measurement. However, recent problems with the ink used for marking has resulted in swatches being supplied without ink markings. Users should be aware that the current method (Jan 2009) for determining the correct side of the swatch for measurement is to align the “V” cut in the swatch to the top left corner when the swatch is in a portrait orientation (see illustration below). Any changes in this protocol will be advised by the material supplier.
